TMI-2 CORE HORSESHOE RING EXAMINATIONS

Published October 1987

**EG&G Idaho, Inc.
Idaho Falls, Idaho 83415**

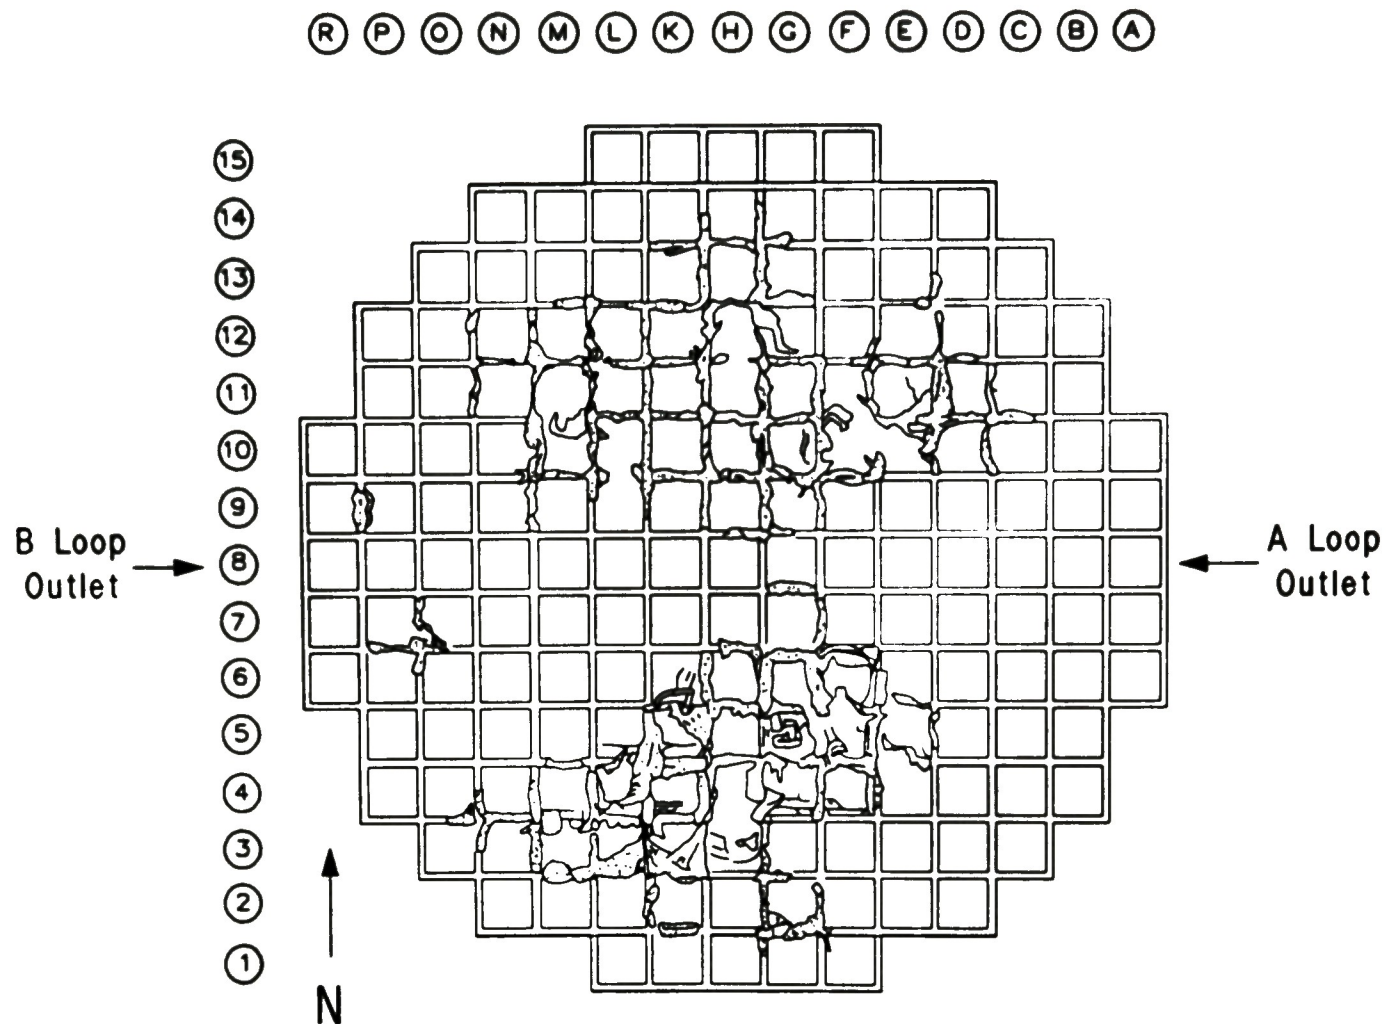
Figure B-10. Damage map of the TMI-2 fuel assembly upper grid plate.

The CCTV examination revealed probable damage to the plenum assembly lower surface as depicted in Fig. B-10.
